SOURCE EMISSIONS SURVEY
OF
KANSAS CITY POWER & LIGHT COMPANY
LA CYGNE GENERATING STATION
UNIT NUMBER 1 SCRUBBER A INLET DUCT
AND UNIT NUMBER 1 STACK
LA CYGNE, KANSAS
FOR
ELECTRIC POWER RESEARCH INSTITUTE

NOVEMBER 1999

FILE NUMBER 99-95LAC1

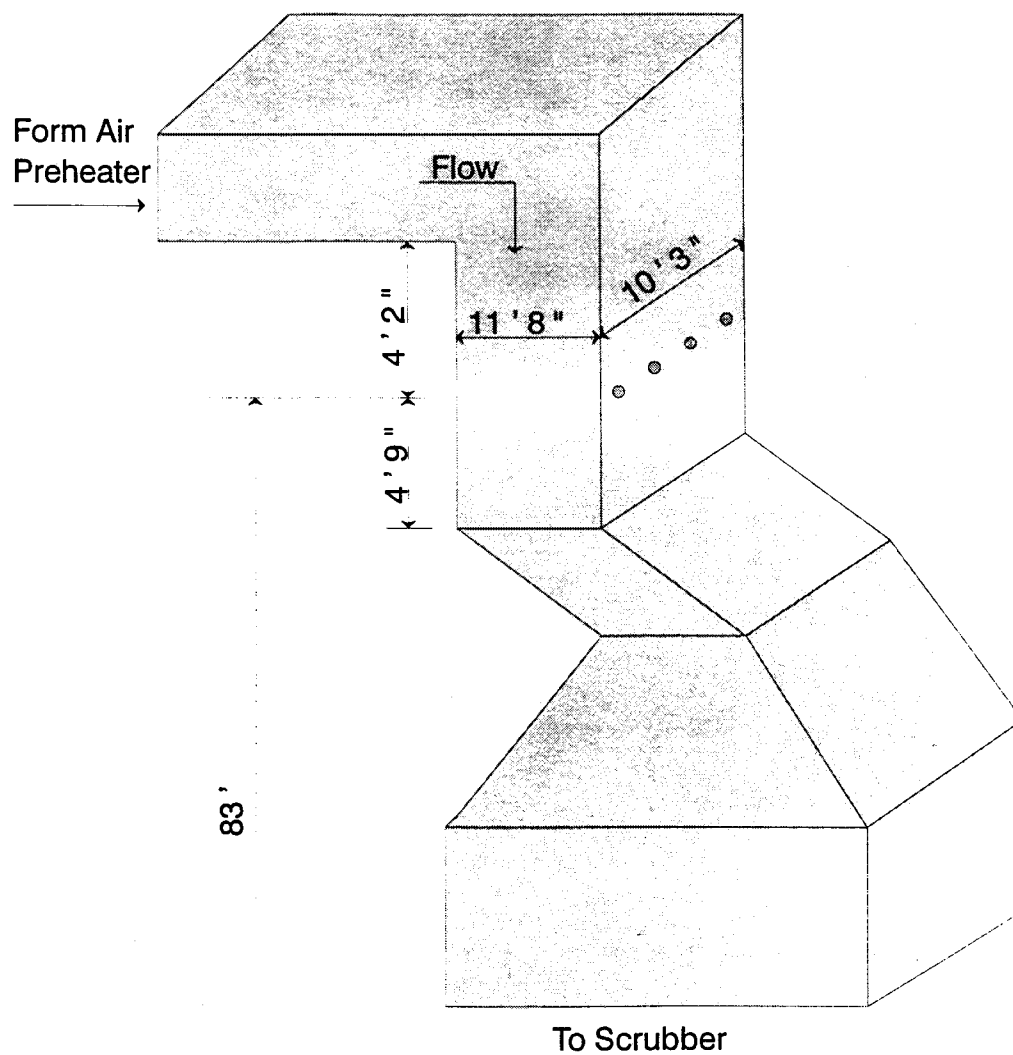
Figure 2-1
Description of sampling locations at La Cygne Unit Number 1 Scrubber A Inlet Duct

The sampling location on the Unit Number 1 Scrubber A Inlet Duct is 83 feet above the ground. The sampling locations are located 4 feet 2 inches (0.38 equivalent duct diameters) downstream from a bend in the duct and 4 feet 9 inches (0.44 equivalent duct diameters) upstream from a bend in the duct.

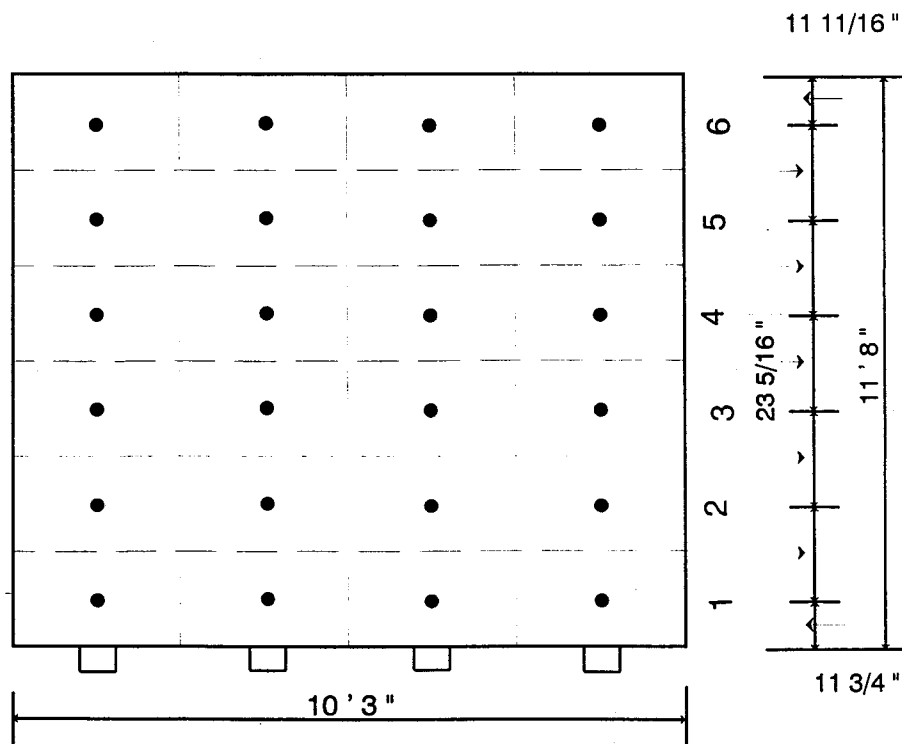
Figure 2-2
Description of sampling points at La Cygne Unit Number 1 Scrubber A Inlet Duct

A preliminary velocity traverse was made at each of the four ports on the Unit Number 1 Scrubber A Inlet Duct, in order to determine the uniformity and magnitude of the flow prior to testing. All traverse points were checked for cyclonic flow and the average angle was equal to 2.0 degrees. Alternate procedures would be required if the angle of cyclonic flow were greater than 20 degrees. Six traverse points were sampled from each of the four ports for a total of twenty-four traverse points at the inlet duct sampling location.

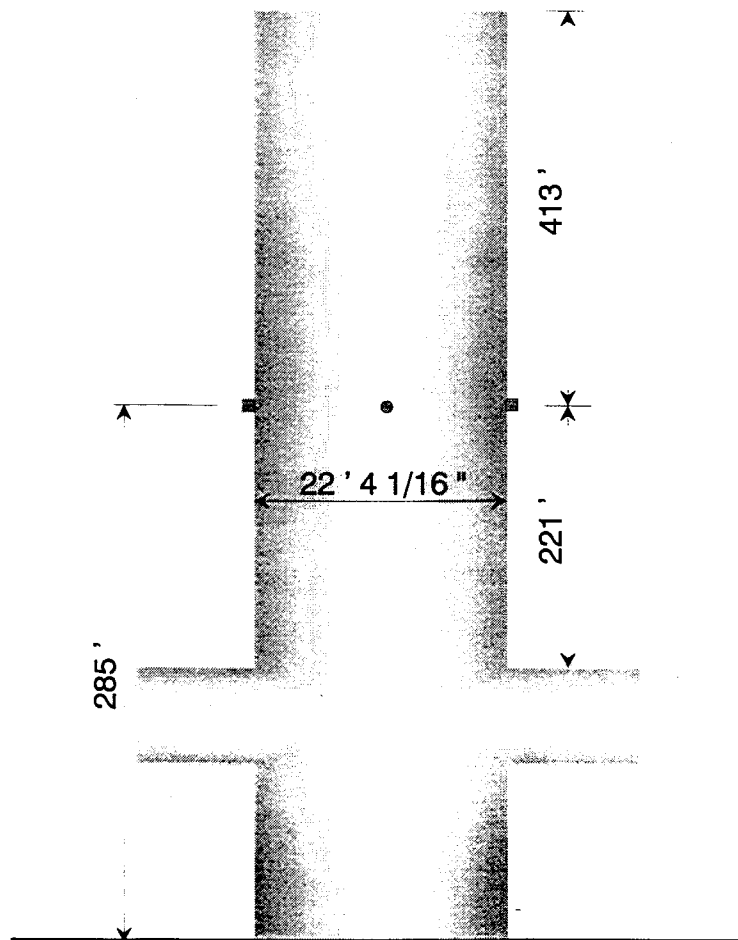
Figure 2-3
Description of sampling locations at La Cygne Unit Number 1 Stack

The sampling location on the Unit Number 1 Stack is 285 feet above the ground. The sampling locations are located 221 feet (9.89 stack diameters) downstream from the inlet to the stack and 413 feet (18.49 stack diameters) upstream from the outlet of the stack.

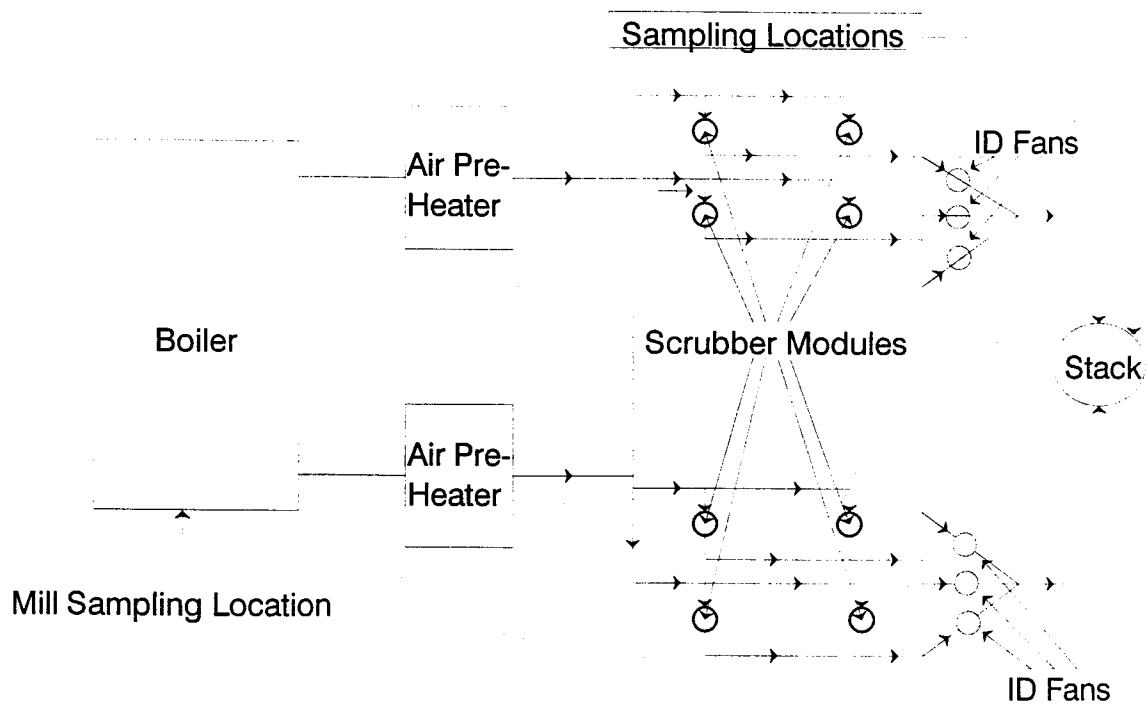
Figure 2-5
Description of coal feeder sampling locations at La Cygne Unit Number 1

The coal sampling locations are located at the inlet of each individual feeder.

ASTM D2234 method of coal sampling was followed. For each test run, a grab sample of coal was collected from the inlet of each individual feeder. One composite sample was prepared for analysis from the individual feeder samples. Each sample was analyzed for mercury, chlorine, sulfur, ash, and Btu content by ASTM Methods D6414-99, E766/300.0, D-4239, D-3174, and D-3286, respectively.
